Historic Structure Report
OLD MAIN LIBRARY
VOLUME I

San Francisco, California

December 10, 1998
Prepared by Page & Turnbull, Inc.

Historic Structure Report
Old Main Library
Volume I

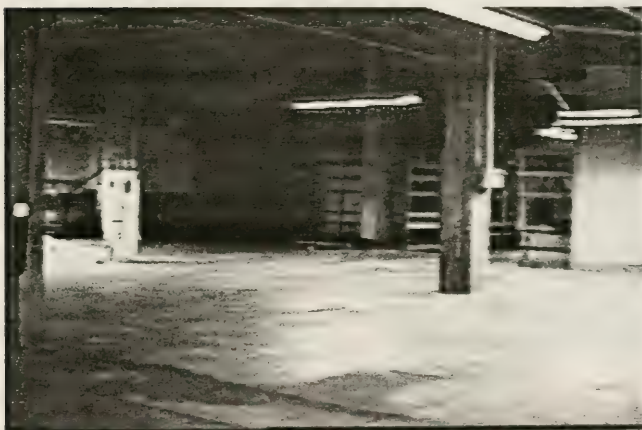
Photograph 1: Room 012. Room view.

Doors (3)		(011, 003, 003B)	
Design		paneled	
Material		wood	
Condition		fair to poor	
Significance		contributing	
Book Chute		Room 001)	
Design		curvilinear	
Material		steel	
Condition		good	
Significance		non-contributing

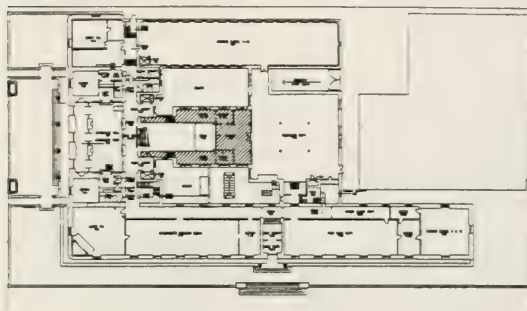
Room Name 117, 117A, 117B, 117C, 117D
 Floor First
 Original Use Workroom
 Recent Use Office and Storage
 Rating Preservation Zone 3

Floor	
Design	utilitarian
Material	battleship linoleum
Condition	poor
Significance	contributing
Walls (original)	
Design	flat
Material	plaster
Condition	fair to good
Significance	contributing
Ceiling	
Design	stepped
Material	plaster
Condition	good
Significance	contributing
Shelves (original)	
Design	utilitarian
Material	wood
Condition	fair
Significance	contributing

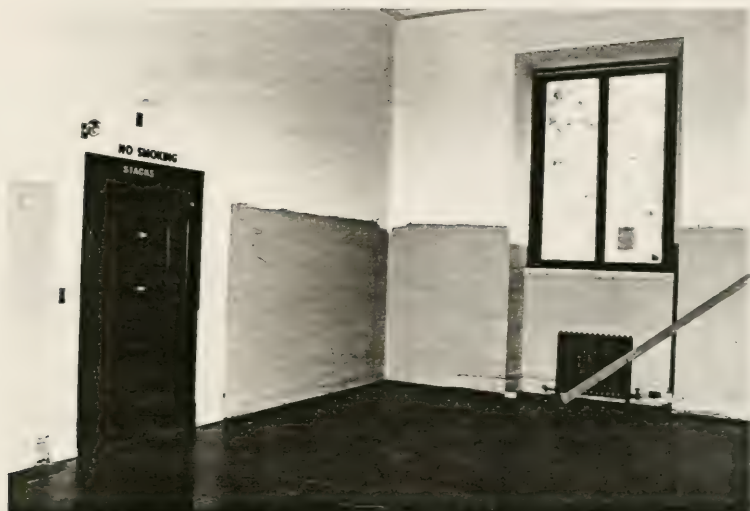
Photograph 1: Room 118B. Room view.

Floor		Window (1) (same as in 118)	
Design	utilitarian	Design	paired casements
Material	battleship linoleum	Material	wood
Condition	poor	Condition	poor to fair
Significance	contributing	Significance	significant
Walls		Door (to ST2)	
Design	flat	Design	paneled
Material	plaster	Material	wood
Condition	fair	Condition	poor
Significance	contributing	Significance	contributing
Ceiling		Door (to 196B)	
Design	flat, with border	Design	large glazed panel
Material	plaster	Material	wood
Condition	fair-good	Condition	good
Significance	significant	Significance	contributing
Doorway and		Lights (fluorescent)	
Design	symmetrical	Design	utilitarian
Material	wood	Material	metal and plastic
Condition	fair-good	Condition	good
Significance	significant	Significance	non-contributing
Base		Radiator (in reveal of south wall)	
Design	molded	Design	rounded top
Material	wood	Material	steel
Condition	poor	Condition	good
Significance	contributing	Significance	contributing

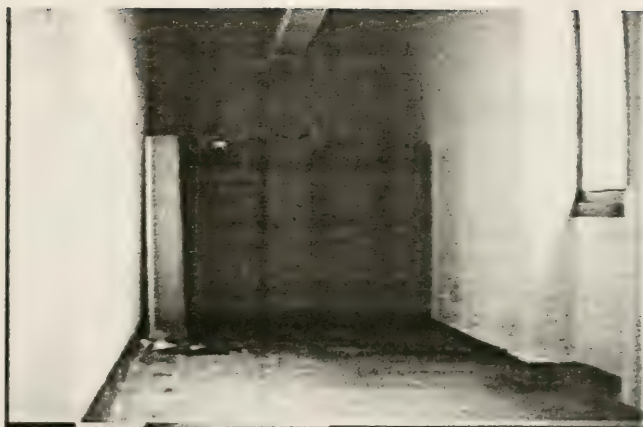
Photograph 17 Room 196A. Room view

Floor		Door (from 196B to ST2)	
Design	10" square tiles	Design	paneled, glazed
Material	vinyl composition	Material	wood
Condition	poor to fair	Condition	fair
Significance	non-contributing	Significance	non-contributing
Walls		Windows (3) (with cremone bolts)	
Design	flat	Design	paired casements
Material	plaster	Material	wood
Condition	poor	Condition	good
Significance	contributing	Significance	significant
Ceiling		Lights (3) (fluorescent)	
Design	flat	Design	ceiling mount
Material	plaster	Material	plastic, metal
Condition	good	Condition	good
Significance	contributing	Significance	non-contributing
Base		Lights (1) (fluorescent)	
Design	profiled	Design	pendant
Material	wood	Material	plastic, metal
Condition	fair, painted	Condition	good
Significance	significant	Significance	non-contributing

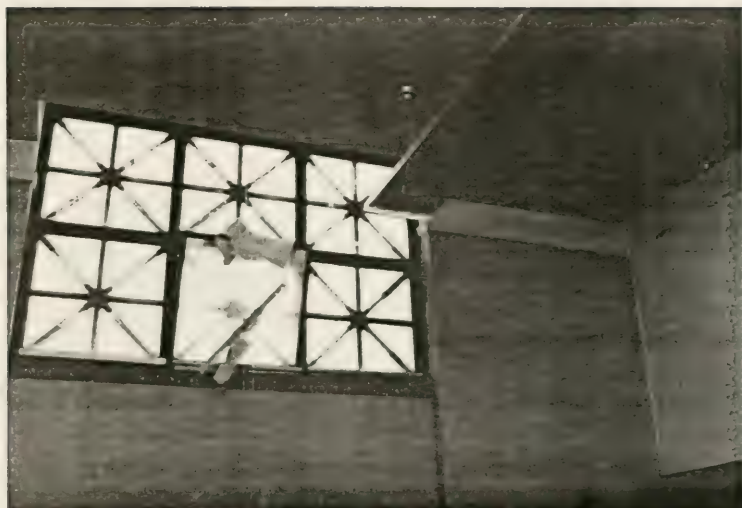
Photograph 4: Room 206 Window, ceiling, and picture rail missing
